VOLTAGE CORRECTION, ATMEGA103L, PROGRAMMING PROBLEMS

#002

Providing the Correct Input Voltage to the ATmega103L Part in the STK300 Board

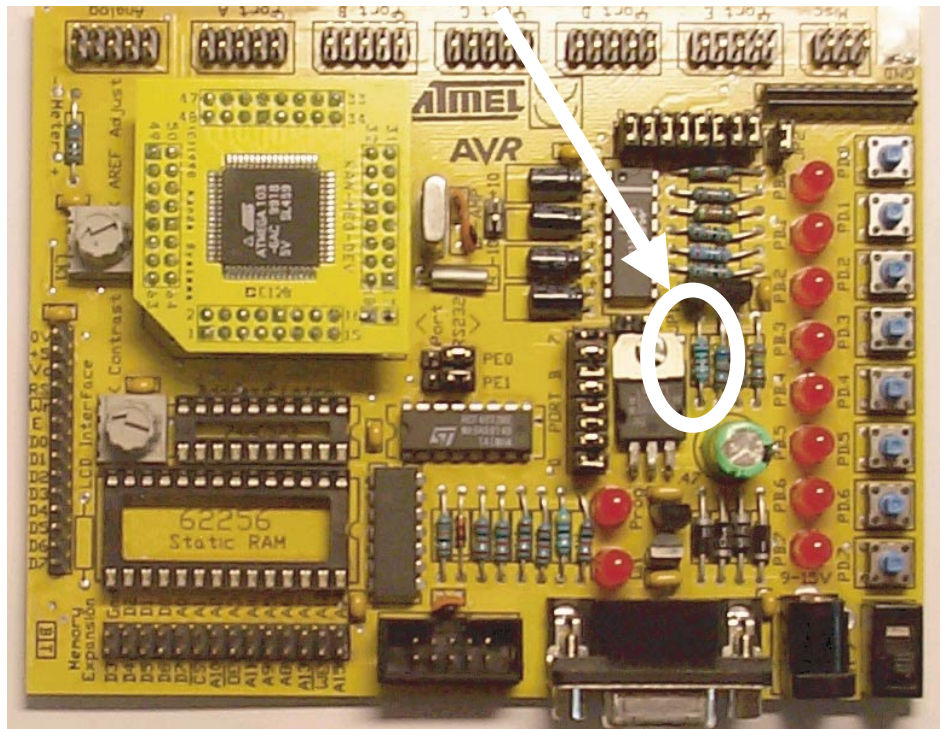
Figure 1. STK300

The supply voltage to the ATmega103L in the STK300 board is inadequate at the low setting. This design note provides the necessary modifications to the development board.

The resistor R7 is located as the first one in the row of resistors beginning to the right of JP1 on the board, above the LEDs, as illustrated in Figure 1 below.

Replace the resistor R7 of 820 Ω with a 1k Ω resistor.
